TECHNICAL WEBINAR

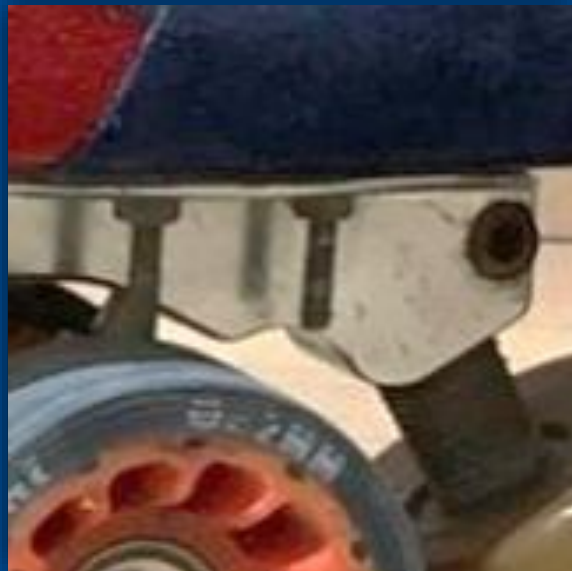
- Incompetence in mounting operation, in this specific case the fixing screws were not shortened and remain protruding excessively and dangerously.

- Mounting operation not carried out in a proper manner, or in any case not following the directives given by Roll-Line, can jeopardize the functioning of the skate and cause damage to wheels and moving parts.

- Rely only on the official sales network.
- Check the quality of the mounting operation by checking that there are no excessively protruding screws.
- Avoid home or artisanal mounting operation.

- Make sure that the mounting screws (in this specific case: traditional “through” mounting) are cut correctly (at the height of the fixing nut).
- Use a cutter of the appropriate size to carry out the operation.

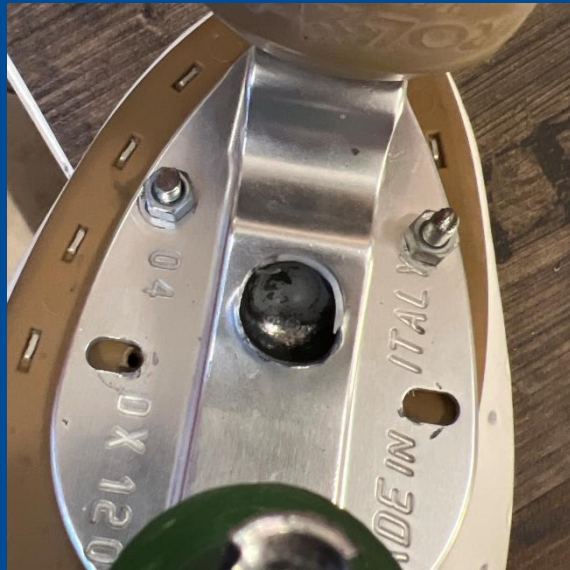
- Incompetence in mounting operation, in this specific case two fixing screws are missing. Roll-Line requires that all holes are used. It is mandatory that only original screws supplied by Roll-Line or the shoe manufacturers are used.

- Mounting operation not carried out in a proper manner, or in any case not following the directives given by Roll-Line, can jeopardize the functioning of the skate and cause damage to wheels and moving parts.

- Rely only on the official sales network.
- Check the quality of the mounting operation by checking that all the required screws are used and that they are not excessively protruding.
- Avoid home or artisanal mounting operation.

- Integrate the missing screws with other compatible ones and complete the assembly according to the required standards.

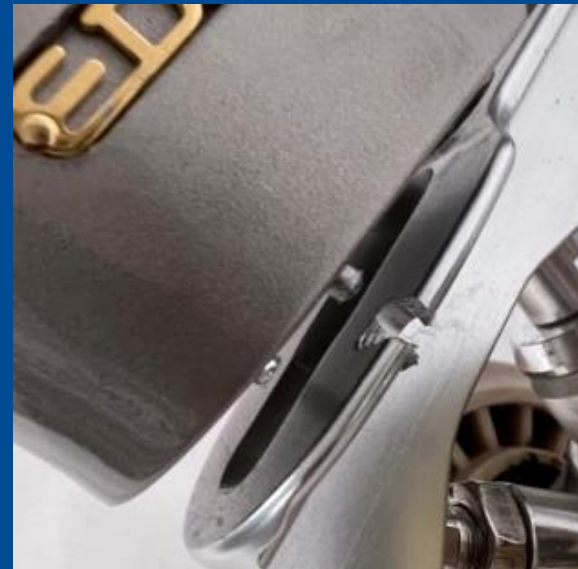
- Use of inappropriate mounting screws.
- Enlarged housing hole during mounting operation.
- Prolonged use of the skate with a missing mounting nut.
- Prolonged use of a loose mounting screw or whose head has blown off.

- Using screws not supplied by Roll-Line or major skating boot manufacturers.
- The prolonged use of one or more loose mounting screws or whose head has fallen off (quick mounting operation) or the prolonged use of the skate in the absence of the fixing nut (traditional "through" mounting operation) represents an evident lack of maintenance which automatically voids the warranty coverage.

- Periodically check the tightness of the fixing nuts or the good condition of the mounting screws to prevent the excessive vibrations produced by an imperfect anchoring from causing damage to the plate as highlighted in the example photo.

- In this case you can intervene by creating a new hole on the rear part of the frame, close to the original one.
- Use the 4.5mm bit normally used to make "through" mountings to create the new housing and proceed with the traditional mounting.
- On the Evo, this hole is already present and can therefore be used as a reference.

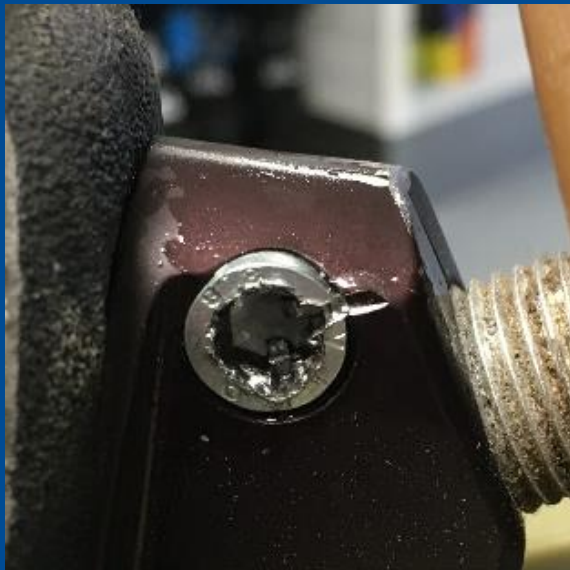
- Excessive tightening of the toestop screw.
- Incorrect use of the Allen key.
- Lack of grease on the toestop screw and stem.
- Excessively worn toestop which leads to having to unscrew it too much with consequent lack of support for adequate tightening.

- Using the toestop screw or the toestop itself without the presence of lubricating grease is a clear lack of maintenance which automatically invalidates the warranty coverage.
- In fact, this leads to having to overtighten the screw which ends up being ruined.

- Use Teflon grease (commonly available at hardware stores) and periodically be sure to apply it to the screw and toestop housing on the frame.
- Use the Allen key correctly, inserting it exactly into its seat.
- Do not tighten further once you are sure the toestop is stable.

- In this case it is advisable to replace the toestop screw (code STVTBFR2)
- If the head is excessively worn such that it cannot be unscrewed with an Allen key, it is necessary to contact an expert dealer.
- Alternatively, you can “blow out” the screw head with a 5mm drill bit. (⚠ The operation requires some experience and manual skills).

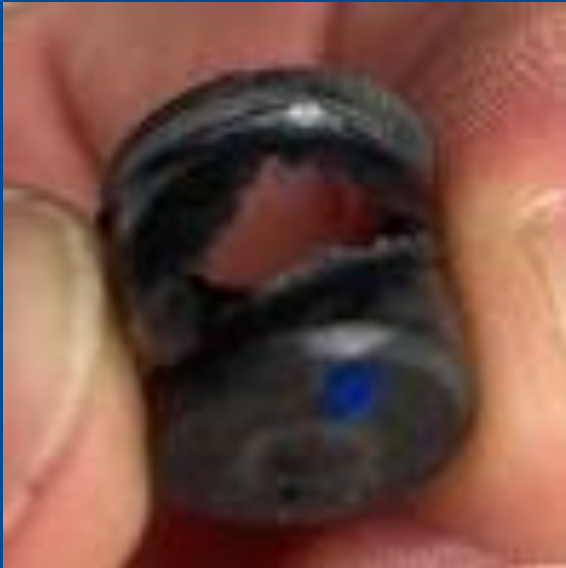
- Failure to replace the part despite it being a consumable part.
- Loose pivot pin which if not adjusted for a long time caused wear of the pivot cup.
- Excessively soft cushions with a lot of play causing abnormal vibrations and excessive wear of the part.

- The pivot cup is a consumable part that must be periodically checked and, if necessary, replaced.
- Cushions and other moving parts must be properly adjusted at all times.
- The omission of these precautions represents a clear lack of maintenance which automatically voids the warranty coverage.

- Carry out a periodic check of all the components of the skate at an authorized dealer and replace any worn parts.

- In this case it is necessary to remove the damaged pivot cup(code STSFN) and replace it with a new one.

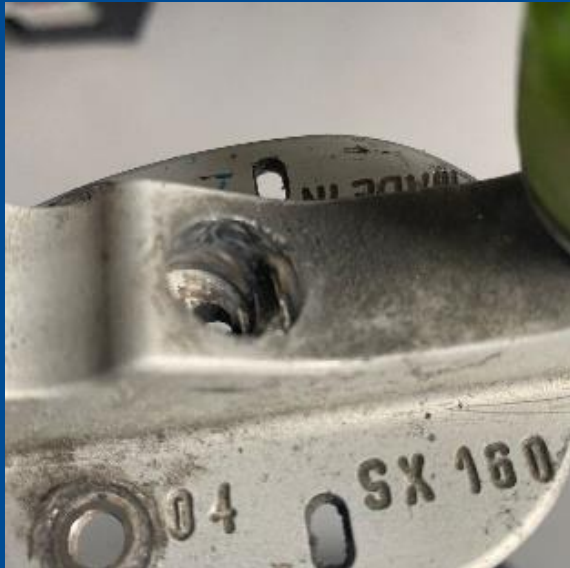
- Trucks incorrectly adjusted that have worn out the pivot cup.
- Loose pivot pin, which not adjusted for a long time caused wear of the pivot cup.
- Failure to replace the pivot cup which had deteriorated (caused by the factors listed above).

- Using the skate without the pivot cup totally compromises the correct functionality of the product.
- Direct contact of the pivot pin on the frame causes no longer repairable damages.
- This represents a clear lack of maintenance which automatically voids the warranty coverage.

- Contact one of the official retailers when you notice excessively worn parts and/or anomalous behavior of the skate such as vibrations, oscillations, instability, etc.

- In this case it is necessary to insert a new pivot cup (code STSFN).
- If the frame is excessively worn or damaged, it may need to be replaced.

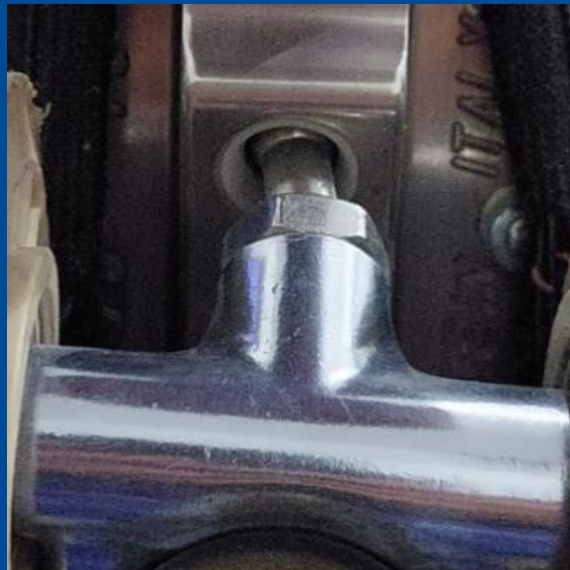
- Numerous falls.
- Wrong pick position before jumps.
- Pivot pin wrongly adjusted (excessively screwed inside the truck) that consequently does not touch the pivot cup.
- Too open steering block resulting in an excessive truck play.

- The pivot pin, like many other steering parts, is subject to significant wear and stress forces.
- Therefore it is to be considered as a consumable part and periodically changed even if it has no visible damage.

- In the evolution of the skaters' skills there are some fundamental steps, one of them is the moment when they move from double to triple jumps. During this transition period, the number of falls generally increases considerably during training. In this phase the trucks are particularly stressed and despite their robustness it may be normal for some to be damaged. It is imperative to prevent critical situations by frequently checking for bent axles or bent pivot pins.

- In this case, you need to remove the pivot pin and replace it with a new one.
- Check that the housing on the truck is not damaged, in which case the entire truck need to be replaced.
- Be sure to secure the pivot pin with a drop of thread lock.
- If the athlete presents the problem several times, it may be useful/necessary to use a titanium pin (code PUTF).

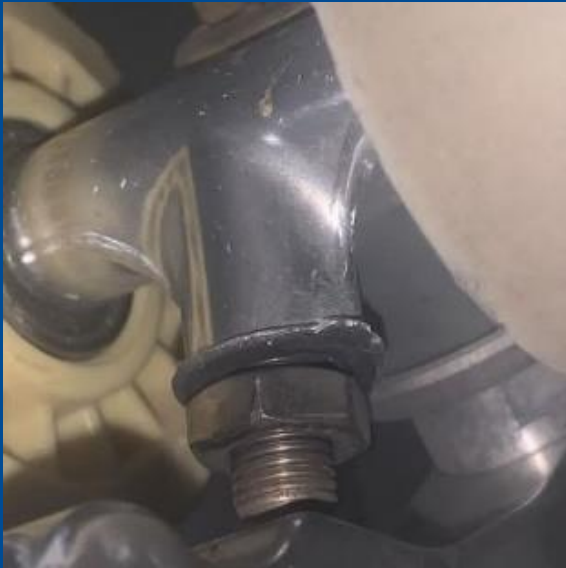
- Numerous falls.
- Wrong pick position before jumps.
- Pivot pin wrongly adjusted (excessively screwed inside the truck) that consequently does not touch the pivot cup.
- Prolonged use of the skates with a loose pivot pin nut.

- Periodic checking of the pivot pin to verify its correct setting is one of the minimum and mandatory maintenance maneuvers provided for Roll-Line.
- Failure to carry out this operation is a clear lack of maintenance which automatically voids the warranty coverage.

- Periodically check and, if necessary, adjust the pivot pin and tighten the relative nut firmly.
- Follow the instructions on the site in the "Adjustments and maintenance" section of each plate, in the technical data sheets or in the [video tutorial](#) dedicated to the adjustment of the pivot pin published on the Roll-Line YouTube channel.

- In this case you need to replace the pivot pin and check the status of the truck.
- If, as expected, the thread of the pivot pin housing has also been damaged, it will need to be replaced.
- Check whether the necessary truck is the "standard" (code STCRAA) or the "lower" (code STCRASA).

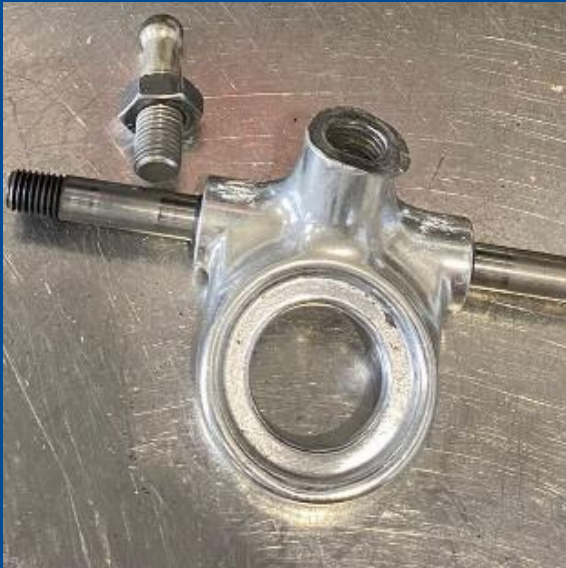
- Prolonged use of the truck with a loose pivot pin nut, creates excessive oscillations of the pivot pin which, over time, damages the internal thread of the truck, making it impossible to fasten with the consequent loss of the component.

- Periodic checking of the pivot pin to verify its correct setting is one of the minimum and mandatory maintenance maneuvers provided for Roll-Line.
- Failure to carry out this operation and allowing this to lead to the consequence in question is a clear lack of maintenance which automatically voids the warranty coverage.

- Periodically check and, if necessary, adjust the pivot pin and tighten the relative nut firmly.
- Follow the instructions on the site in the "Adjustments and maintenance" section of each plate, in the technical data sheets or in the [video tutorial](#) dedicated to the adjustment of the pivot pin published on the Roll-Line YouTube channel.

- In this case you need to replace the pivot pin and check the status of the truck.
- If, as expected, the thread of the pivot pin housing has also been damaged, it will need to be replaced.
- Check whether the necessary truck is the "standard" (code STCRAA) or the "lower" (code STCRASA).

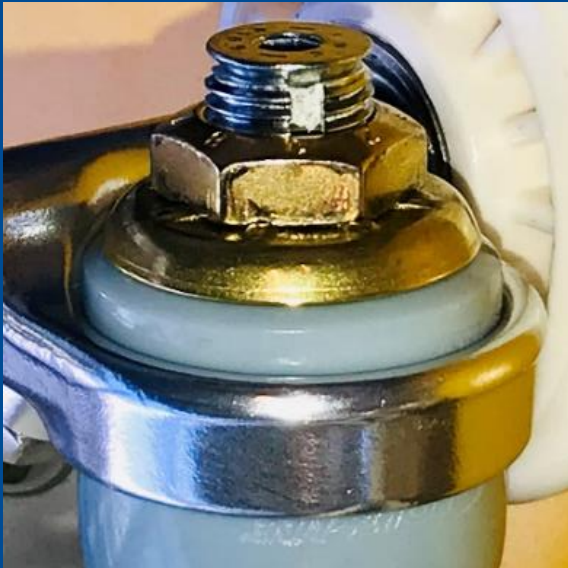
- The hexagonal nut that adjusts the suspension, if in this position, is in an incorrect state of adjustment.
- Prolonged use of the suspensions adjusted in this way can lead to damage to the kingpin and other components such as nuts, cushion cups, trucks and cushions as well as compromising the correct functioning of the skate.

- The steering mechanism must always be kept at maximum efficiency to ensure correct functioning.
- Incorrect adjustment of the steering jeopardizes the correct functioning of the skate, in this specific case the steering can be **EXCESSIVELY HARD** and create episodes of understeer and excessive stability.

- Use the suspension hardness appropriate to your weight and needs.
- Follow the instructions on the site in the "Adjustments and maintenance" section or in the technical data sheets or in the [video tutorial](#) dedicated to suspension adjustment published on the Roll-Line YouTube channel.

- In this case, it is very likely that the skater **NEEDS HARDER SUSPENSIONS**.
- Contact a retailer to purchase the appropriate color set.
- In some cases, it may be useful to adopt only the lower (smaller) suspension of a higher hardness, keeping the upper (larger) one unchanged.
- Consult the [technical table](#) on the website.

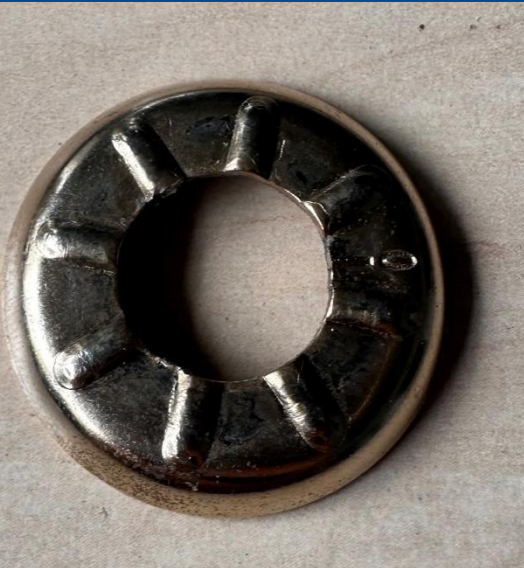
- The click action washer cup got damaged by a prolonged use of too fastened suspensions. Unfortunately this type of adjustment inhibits the correct functioning of the steering system and causes unwanted breakages.

- The steering mechanism must always be kept at maximum efficiency to ensure correct functioning.
- An incorrect adjustment of the steering jeopardizes the correct functioning of the skate, in this specific case it may lead to the rupture of the internal struts as shown in the picture.

- Use the suspension hardness appropriate to your weight and needs.
- Follow the instructions on the site in the "Adjustments and maintenance" section or in the technical data sheets or in the [video tutorial](#) dedicated to suspension adjustment published on the Roll-Line YouTube channel.

- In this case, it is very likely that the skater **NEEDS HARDER SUSPENSION**.
- Contact a retailer to purchase the appropriate color set.
- Adjust the steering so that the 8-clicks nut is in the so-called standard position.
- Consult the [technical table](#) on the website.

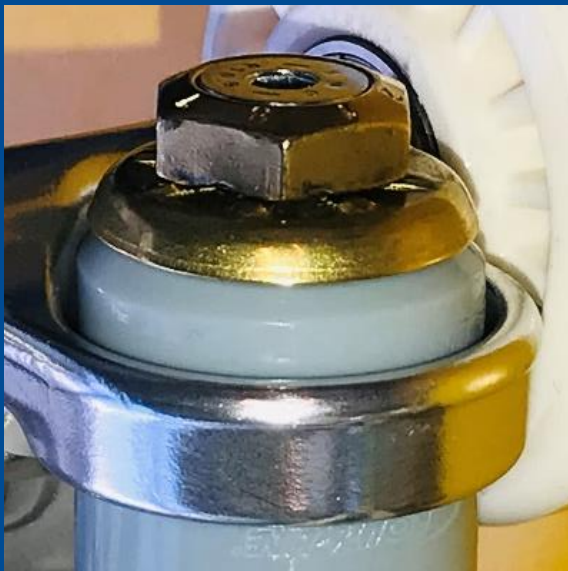
- The hexagonal nut that adjusts the suspension, if in this position, is in an incorrect state of adjustment.
- Prolonged use of the suspensions adjusted in this way can lead to damage to the kingpin and other components such as nuts, cushion cups, trucks and cushions as well as compromising the correct functioning of the skate.

- The steering mechanism must always be kept at maximum efficiency to ensure correct functioning.
- An incorrect adjustment of the steering jeopardizes the correct functioning of the skate, in this specific case the steering can be **EXCESSIVELY SOFT** and create episodes of oversteer and instability.

- Use the suspension hardness appropriate to your weight and needs.
- Follow the instructions on the site in the "Adjustments and maintenance" section or in the technical data sheets or in the [video tutorial](#) dedicated to suspension adjustment published on the Roll-Line YouTube channel.

- In this case, it is very likely that the skater **NEEDS SOFTER SUSPENSION**.
- Contact a retailer to purchase the appropriate color set.
- Adjust the steering so that the 8-clicks nut is in the so-called standard position.
- Consult the [technical table](#) on the website.

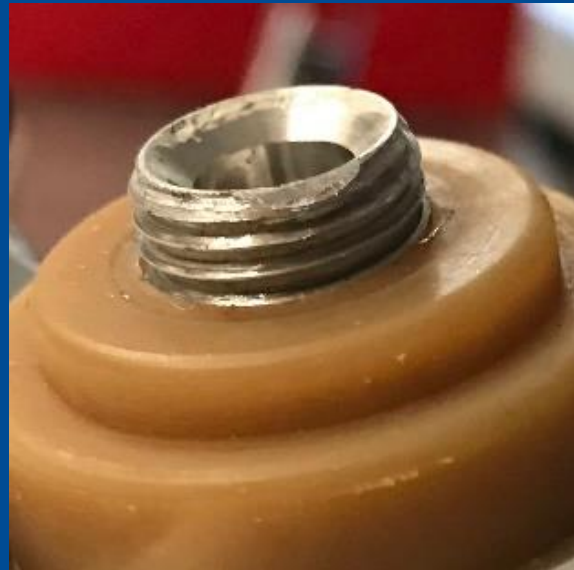
- This type of damage generally occurs with the prolonged use of the skate with an incorrect steering adjustment.
- Typically, this occurs due to an excessively open steering.
- The excessive play created by this incorrect adjustment causes damage to the thread of the kingpin over time, making it very difficult (when not impossible) to reinsert the nut after changing the cushions.

- This damage can be avoided by using the correct color of cushions and consequently positioning the adjustment nut within the intended limits of use.
- Incorrect adjustments of the steering jeopardizes the correct functioning of the skate and leads to damage to the parts involved.

- Use the appropriate hardness of cushions for your weight and needs.
- Follow the instructions on the website in the "Adjustments and maintenance" section, in the technical data sheets or in the [video tutorial](#) dedicated to suspension adjustment published on the Roll-Line YouTube channel.

- In this case it is necessary to replace the kingpin.
- Use a 16mm or 17mm wrench according to the model of plate.
- Check the required kingpin model.

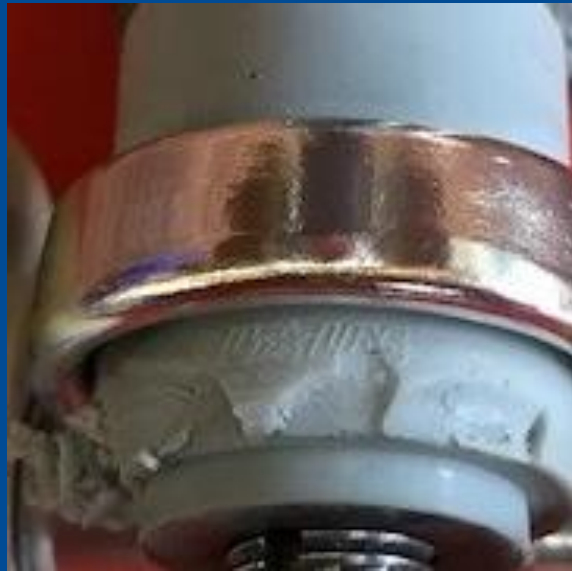
- This damage is a direct consequence of what was analyzed in the previous case.
- An excessively soft lower suspension positioned in correspondance of the truck used for landing from the jumps is not suitable to withstand the stresses of the case.

- This damage can be avoided by using the correct suspension set and consequently positioning the adjustment nut within the intended limits of use.
- Incorrect adjustment of the steering jeopardizes the correct functioning of the skate and leads to damage to the parts involved.

- Replace the damaged cushion.
- Follow the instructions in the [video tutorial](#) dedicated to the replacing of the cushions published on the Roll-Line YouTube channel.
- In some cases it may be useful to adopt the lower (smaller) suspension of a higher hardness, keeping the upper (larger) one unchanged.

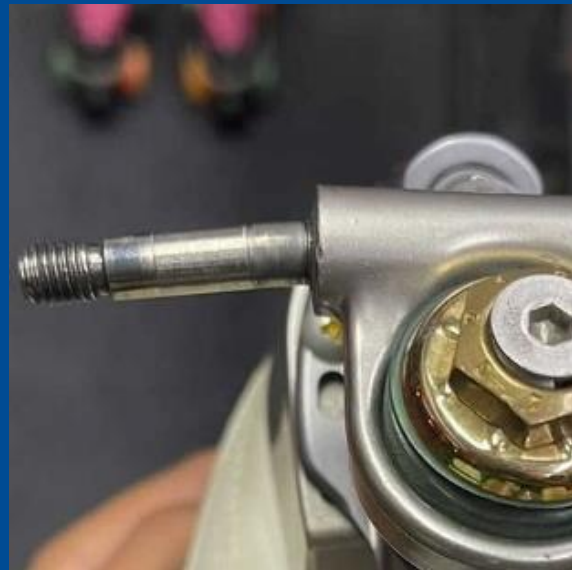
- Numerous falls.

- Truck axles, as well as many other steering parts, are subject to significant wear and stress forces.
- Therefore, they are to be considered as consumable parts and periodically changed even if there is no visible damage.
- This applies in particular to skaters of the "free" specialty as their skates are more stressed by falls during landing from not correctly performed jumps.

- In the evolution of the skaters' skills there are some fundamental steps, one of them is the moment when they move from double to triple jumps. During this transition period, the number of falls generally increases considerably during training. In this phase the trucks are particularly stressed and despite their robustness it may be normal for some to be damaged. It is imperative to prevent critical situations by frequently checking for bent axles or bent pivot pins.

- In this case you need to replace the truck.
- Check whether the necessary truck is the "standard" (code STCRAA) or the "lower" (code STCRASA).
- The use of the spacer (code STDI92) reinforces the axle of the truck and helps prevent damage of this type.

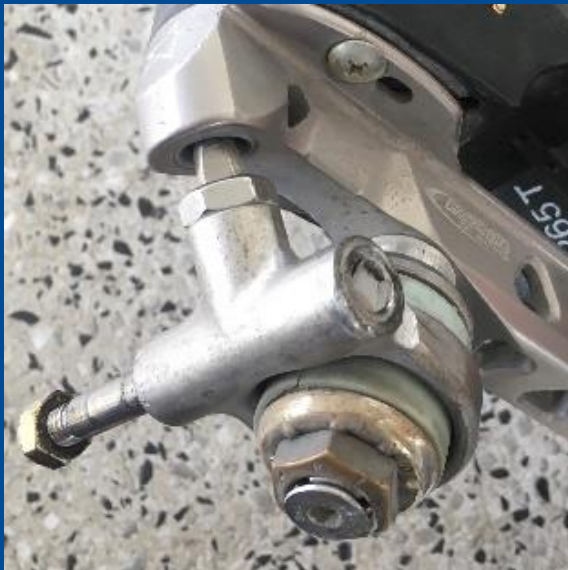
- Numerous falls.

- Truck axles, as well as many other steering parts, are subject to significant wear and stress forces.
- Therefore, they are to be considered as consumable parts and periodically changed even if there is no visible damage.
- This applies in particular to skaters of the "free" specialty as their skates are more stressed by falls during landing from not correctly performed jumps.

- In the evolution of the skaters' skills there are some fundamental steps, one of them is the moment when they move from double to triple jumps. During this transition period, the number of falls generally increases considerably during training. In this phase the trucks are particularly stressed and despite their robustness it may be normal for some to be damaged. It is imperative to prevent critical situations by frequently checking for bent axles or bent pivot pins.

- In this case you need to replace the truck.
- Check whether the necessary truck is the "standard" (code STCRAA) or the "lower" (code STCRASA).
- The use of the spacer (code STDI92) reinforces the axle of the truck and helps prevent damage of this type.

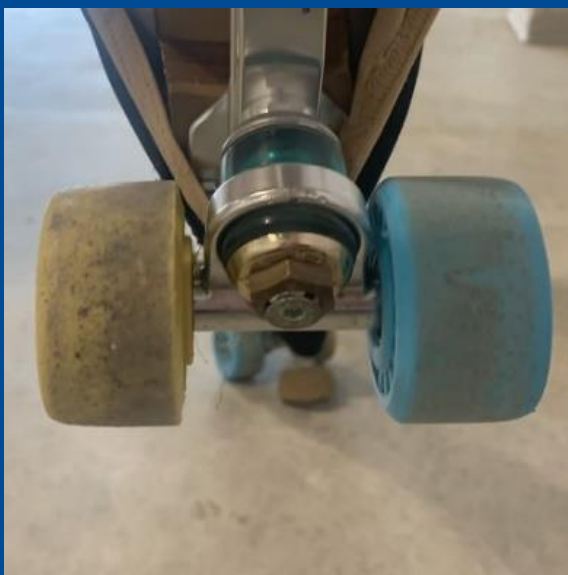
- This level of consumption is normal.
- The signal that the usage limit has been reached is given by the conical shape of the wheel.
- Further use of the wheel in these conditions is highly discouraged.

- Replace the excessively worn wheel.
- To extend the life of your wheels, it may be helpful to move the wheel from an internal to an external position and vice versa.
- Follow the instructions on the website in the "Periodic change" section of each wheel or the specific [technical table](#).

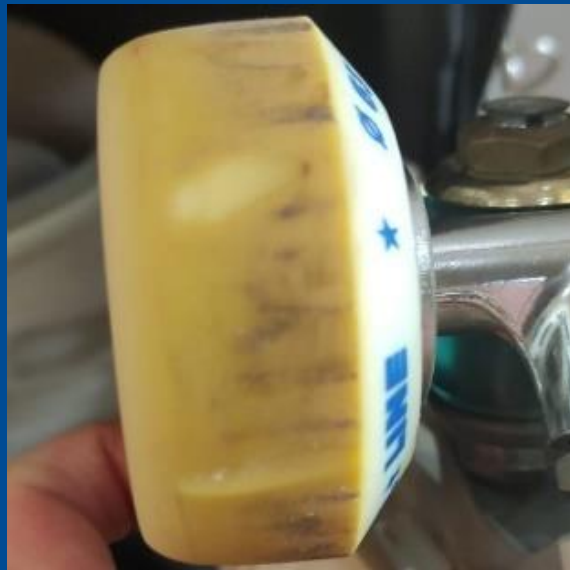
- This type of damage is mainly due to unevenness in the floor.
- In particular, misaligned parquet strips act like blades on the wheels, especially on polyurethane wheels, causing damage like the one in the photo.
- Unfortunately this is an external cause and cannot be traced back to Roll-Line.

- Periodically check the surface of the training track to promptly locate damaged areas, splinters or protruding blocks.

- Sand and/or repair the floor where necessary to make the entire surface as homogeneous as possible. Evitare quanto più possibile le frenate laterali, specialmente durante gli allenamenti, in fase di avvicinamento alla balaustra e/o al bordo pista.

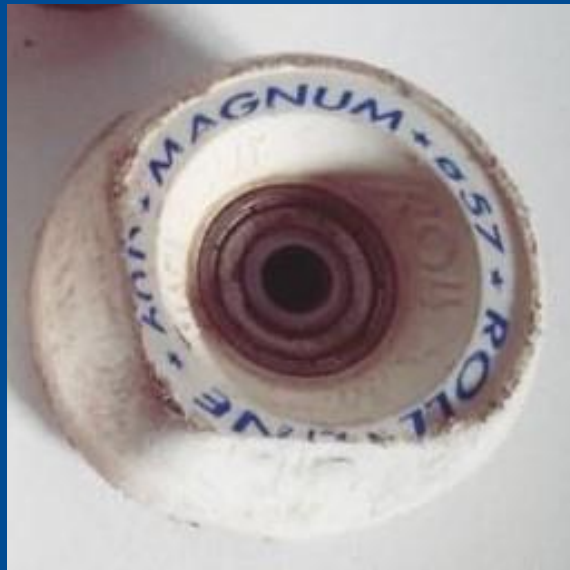
- The wheels are a fundamental part of the skate and must always be clean, worn evenly (all 8 at the same time) and used within their limits.
- A wheel in these conditions does not comply with any of the manufacturer's instructions and significantly compromises the quality of the skating, making it totally ineffective.

- The wheels, as well as many other parts of the skate, are subject to significant wear forces.
- Therefore they are to be considered as consumables and periodically changed when they reach their usage limit.
- Follow the instructions for each wheel on the website in the "Periodic change" section.

- Avoid such obvious material consumption as much as possible.
- Follow the instructions in the "Periodic change" section of each wheel or the specific [technical table](#).

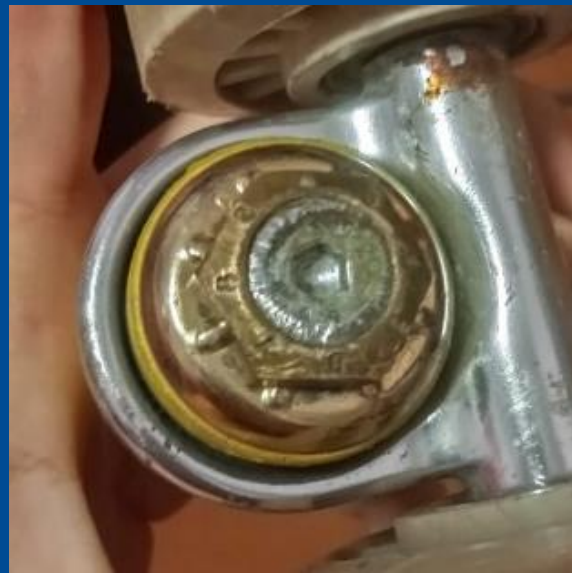
- Use of excessively worn or unsuitable diameter wheels.
- Use of indoor wheels with 57/55 diameter on external and rough surfaces such as road asphalt.

- The use of wheels with a diameter designed for "free" (Ø57/55) or any other excessively worn type may result in the lower part of the cross scraping against the surface and causing the damage visible in the photo.
- Roll-Line produces specific wheels for road use, the use of different or excessively worn wheels automatically voids the warranty coverage.

- In this case it is advisable to replace the steering lock screw (code STVTBDD) and the nut (code STDDRPS8T) if with 8 clicks; or (code STDDRPSAMR) if for Variant M/ Blaster.
- Follow the instructions in the [video tutorial](#) dedicated to replacing suspensions published on the Roll-Line YouTube channel.

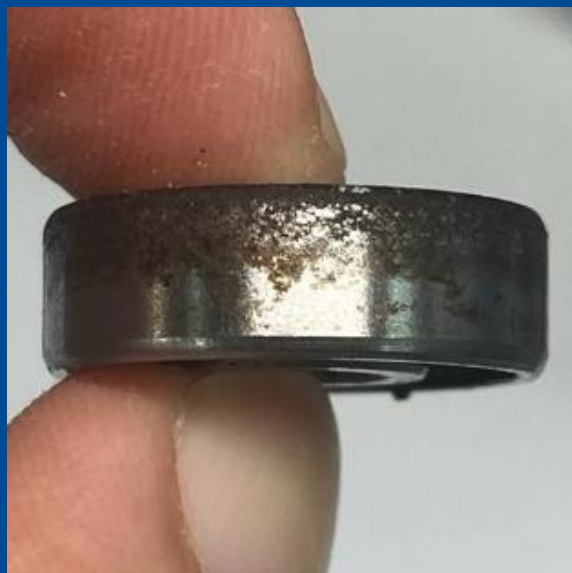
- Bearing left in a humid environment such as a sports bag containing sweaty post-workout skates.
- Lack of lubrication and periodic cleaning.

- The bearings are a consumable part that must be periodically lubricated to guarantee maximum efficiency and regularly replaced as clearly indicated on the site in the "Periodic change" section in each bearing.
- Prolonged use of a bearing that is not properly lubricated and cleaned is a clear lack of maintenance which automatically voids the warranty coverage.

- It is recommended to clean the bearings periodically.
- If used assiduously (frequent training and competition) the bearings should be replaced periodically (6 months) to guarantee excellent performance.
- It is advisable to always keep a spare set of bearings to use before or during competitions in order to increase the speed of execution.

- Remove the bearings from the wheels using the related [bearing press](#).
- Use specific products from the Roll-Line® range for [cleaning](#) and [lubrication](#).
- Avoid aggressive products (alcohol, petrol, etc.)
- Follow the instructions in the [video tutorial](#) dedicated to bearings published on the Roll-Line YouTube channel.

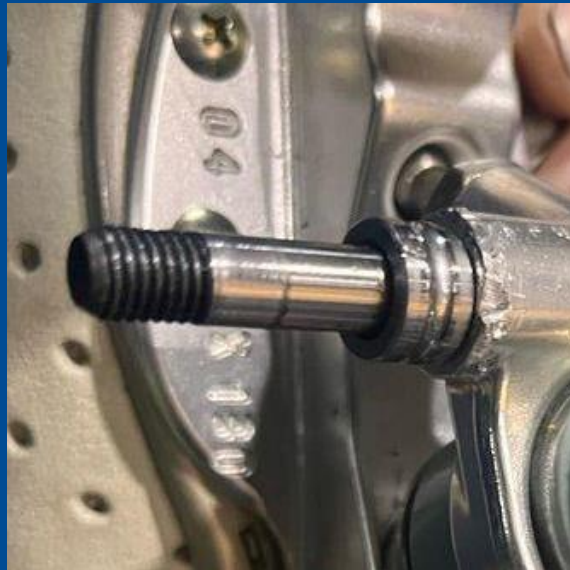
- The bearings are a consumable part that must be periodically lubricated to guarantee maximum efficiency and regularly replaced as clearly indicated on the site in the "Periodic change" section in each bearing.
- Prolonged use of a bearing that is not properly lubricated and cleaned is a clear lack of maintenance which automatically voids the warranty coverage.

- It is recommended to clean the bearings periodically.
- If used assiduously (frequent training and competition) the bearings should be replaced periodically (6 months) to guarantee excellent performance.
- It is advisable to always keep a spare set of bearings to use before or during competitions in order to increase the speed of execution.

- Remove the bearings from the wheels using the related [bearing press](#).
- Use specific products from the Roll-Line® range for [cleaning](#) and [lubrication](#).
- Avoid aggressive products (alcohol, petrol, etc.)
- Follow the instructions in the [video tutorial](#) dedicated to bearings published on the Roll-Line YouTube channel.
